Debris/Ice/TPS Assessment and Integrated Photographic Analysis of Shuttle Mission STS-87

*Process Engineering/Mechanical System Division/ET-SRB Branch,
Kennedy Space Center, Florida*

**DEBRIS/ICE/TPS ASSESSMENT
AND
INTEGRATED PHOTOGRAPHIC ANALYSIS
OF
SHUTTLE MISSION STS-87**

19 November 1997

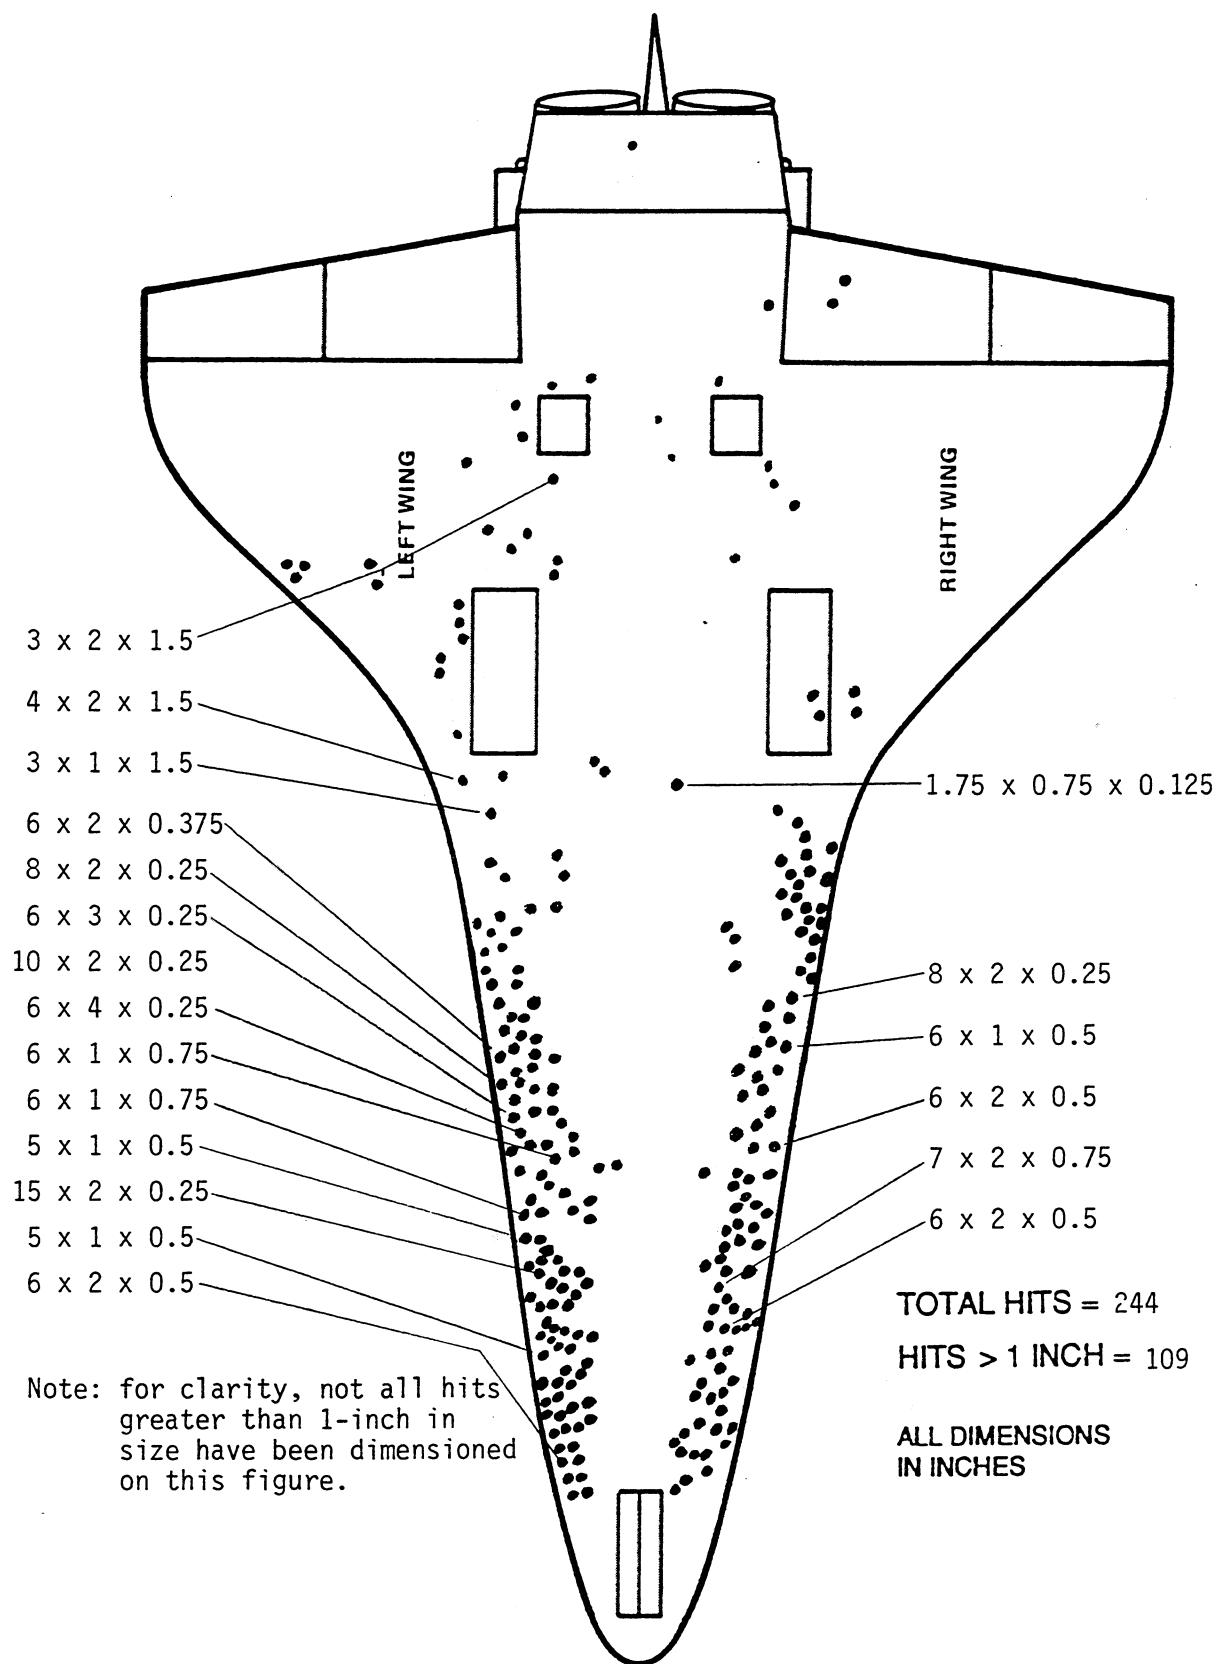
Figure 1: Orbiter Lower Surface Debris Damage Map

The Orbiter lower surface sustained at least 244 significant hits, of which 109 had a major dimension of 1-inch or larger. Virtually all of this unusual damage was concentrated in the area between the nose landing gear and the main landing gear more or less symmetrically divided between left and right outboard sides. The largest lower surface tile damage site was located on the left glove. The site measured 15-inches long by 2-inches wide by 0.25-inches deep. The deepest lower surface tile damage site was located just forward of the left main landing gear well. It measured 4-inches long by 2-inches wide by 1.5-inches deep. Tile material in the damage sites showed signs of glazing and heat effects from re-entry. The damage sites with significant depth appeared to be generally aligned in a fore to aft direction. Many of these sites were affected by re-entry aerodynamic erosion.

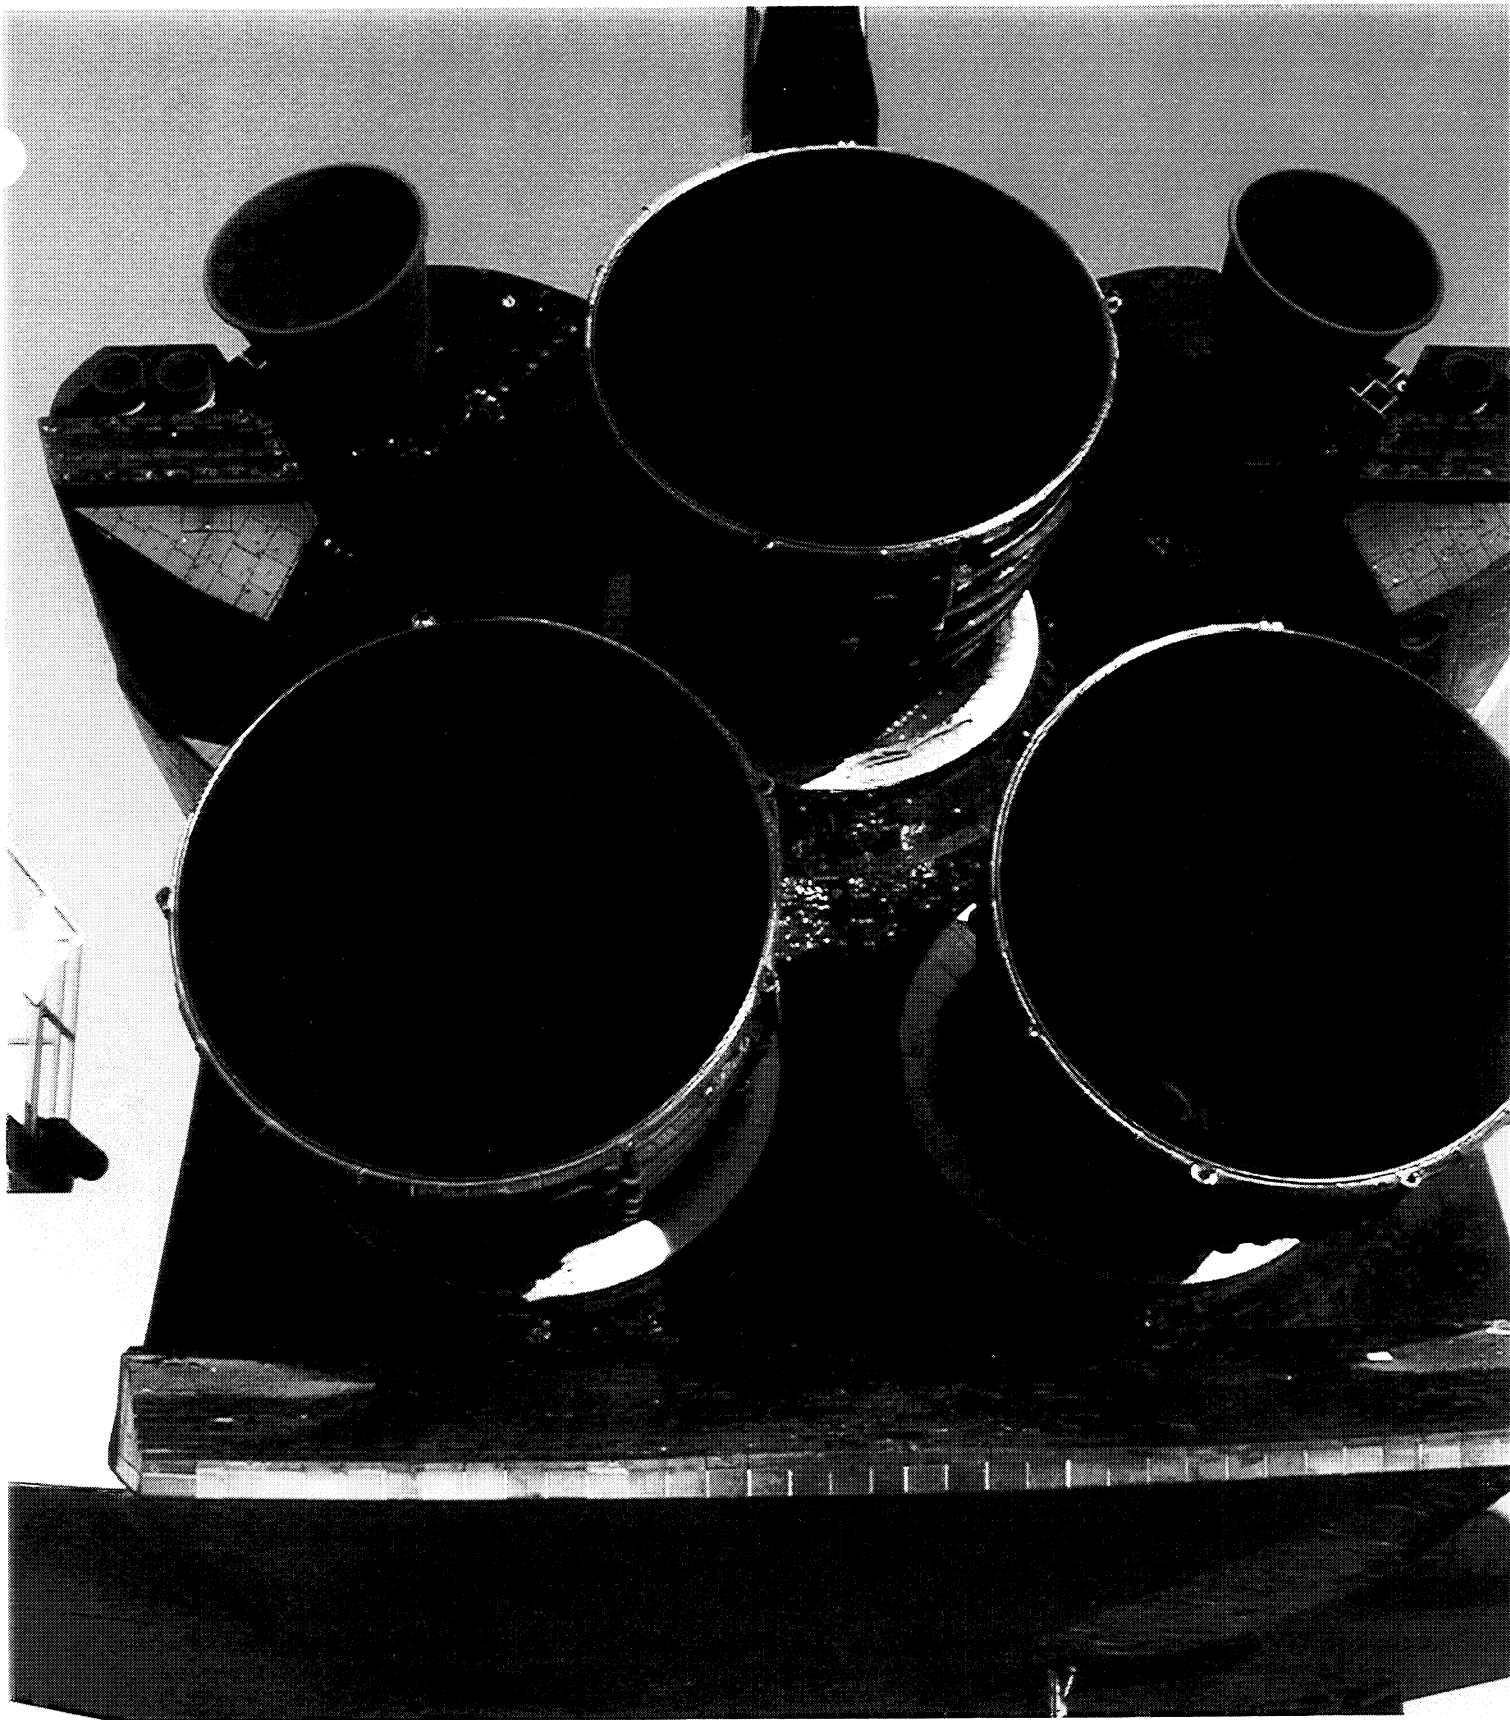
Photo 19: Overall View SSME's/Base Heat Shield

A post landing inspection showed the Orbiter tiles sustained a total of 308 hits, of which 132 had a major dimension of 1-inch or larger. This total does not include the numerous hits on the base heat shield attributed to SSME vibration/acoustics and exhaust plume recirculation. A comparison of these numbers to statistics from 72 previous missions of similar configuration (excluding missions STS-23, 24, 25, 26, 26R, 27R, 30R, and 42, which had damage from known debris sources), indicates both the total number of hits and the number of hits 1-inch or larger was "out of family".

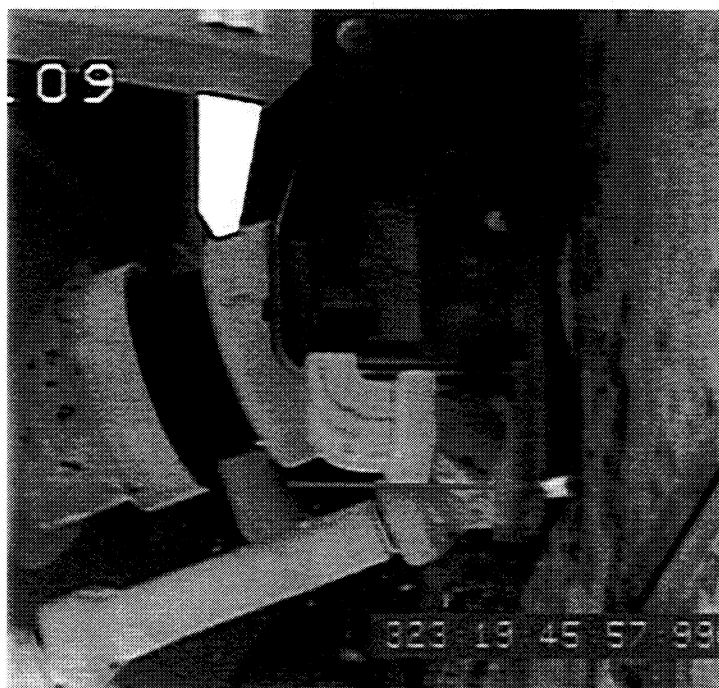
Figure 2.1 (A) Umbilical Ice Striking LH2 Umbilical Door Sill

Multiple pieces of ice debris were seen falling from the ET/Orbiter umbilicals during SSME ignition. An ice/frost finger from a LH2 umbilical purge vent fell aft and contacted the LH2 press line (~19:45:56.6 UTC) and then struck the LH2 umbilical door sill. Three other pieces of umbilical ice debris were seen to strike the ET/Orbiter LH2 umbilical door sill (~19:45:56.4 through 19:45:58.0 UTC). A single piece of umbilical ice debris was seen to strike the LH2 four-inch recirculation line at ~19:45:56.65 UTC. No damage to the press line, the door sill, or the four-inch recirculation line was visible. (Cameras OTV109, OTV163, E31)

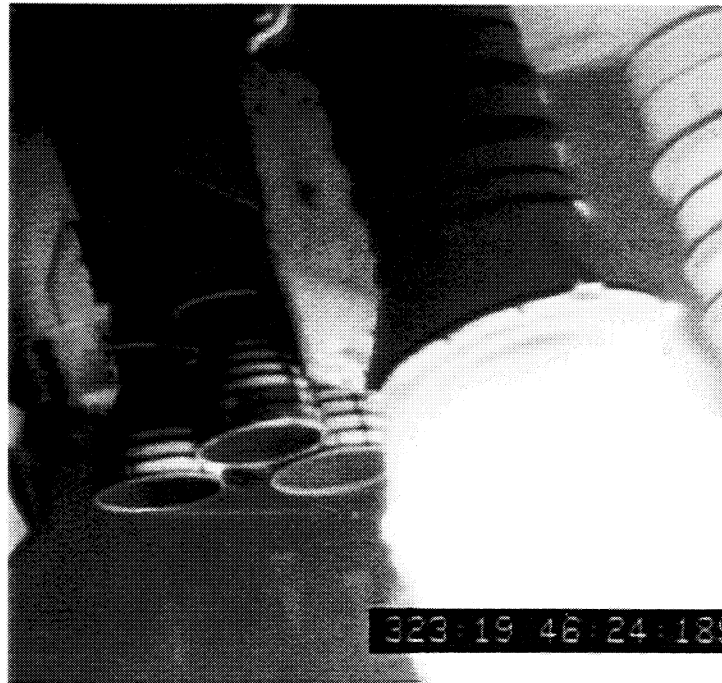
Figure 2.4 (B) Umbilical Purge Barrier Material Adhered to Base Heat Shield

A single piece of debris (possibly umbilical purge barrier material) first seen near the body flap, moved laterally into the SSME exhaust plume, broke into multiple pieces, and fell aft (19:46:24.189 UTC). (Camera ET207)

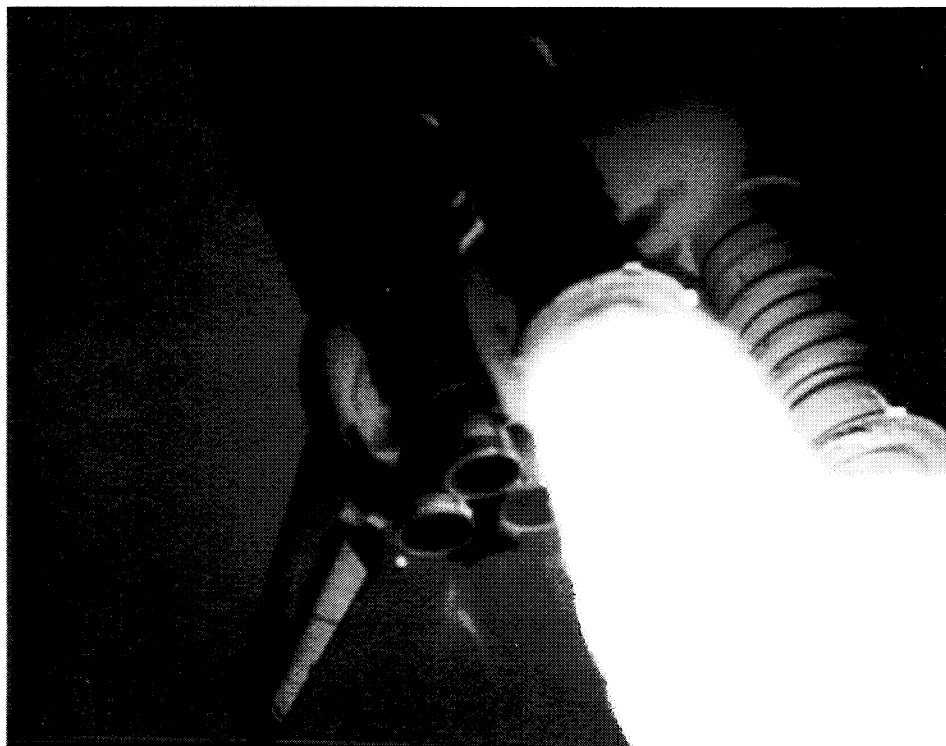
A Dome Mounted Heat Shield (DMHS) closeout blanket was seen to partially detach at the 5 o'clock position of SSME #1 at ~19:46:20.7 UTC.

Figure 2.4 (D) Detached DMHS Closeout Blanket

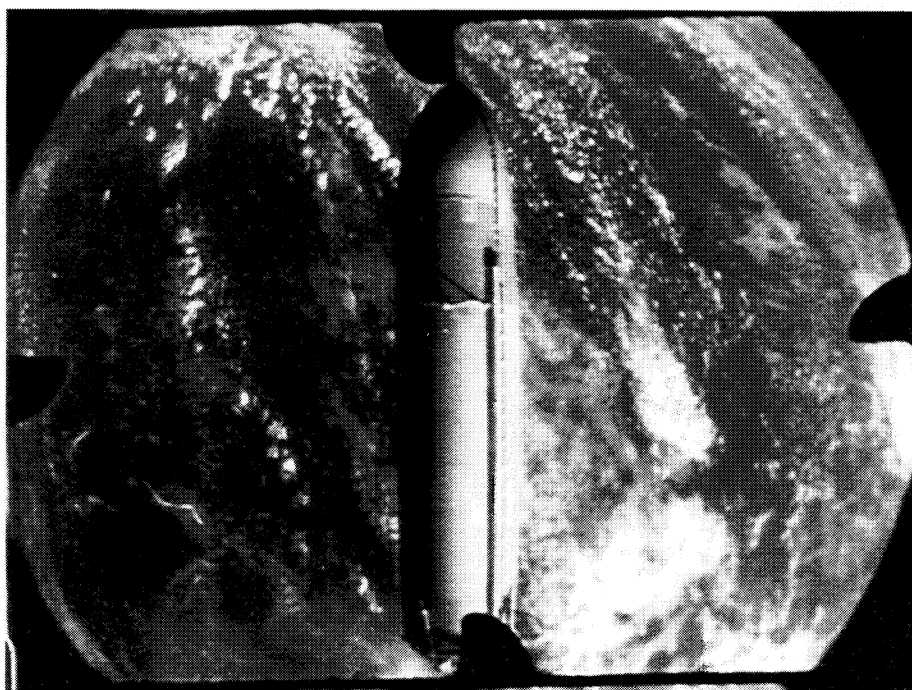
Figure 2.6.1.1 (A) 16mm Umbilical Well Camera Film (5mm Lens) of ET

Good coverage of the LSRB separation and the tip of the RSRB was acquired on the 16mm films. Numerous light-colored pieces of debris (insulation and frozen hydrogen) and dark debris (probably charred insulation) were seen throughout the 16mm film sequence. Numerous irregularly-shaped pieces of debris (charred insulation) were noted near the base of the LSRB electric cable tray prior to SRB separation. Charred TPS was seen on the aft surface of the -Y upper strut fairing prior to SRB separation. Typical ablation of the ET/Orbiter LH2 umbilical electric cable tray and the aft surface of the horizontal section of the -Y ET/SRB vertical strut was seen. Normal blistering of the fire barrier material on the outboard side of the LH2 umbilical was seen. Ablation of the TPS on the aft dome was normal. TPS ablation or small aero-heating erosion marks on the ET aft dome may be slightly more than typically seen.

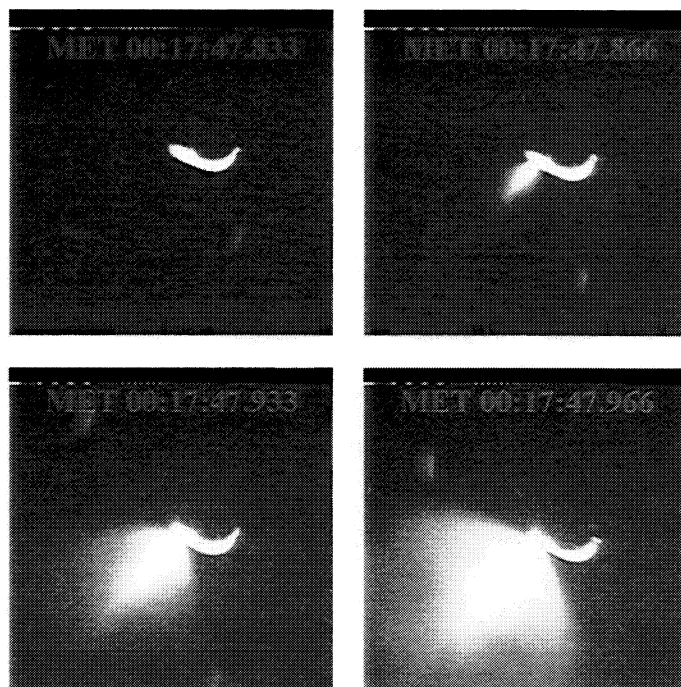
Figure 2.6.1.6 (B) ET Venting

Figure 2.6.1.6 (B) shows venting sequences, that are separated by 1/30th of a second (0.033 seconds). This venting event was identified as a large burst that lasted less than six video frames from MET 17:47.833 through 17:48.033. In Table 2.6.1.6, this venting event was identified in the V2 region.

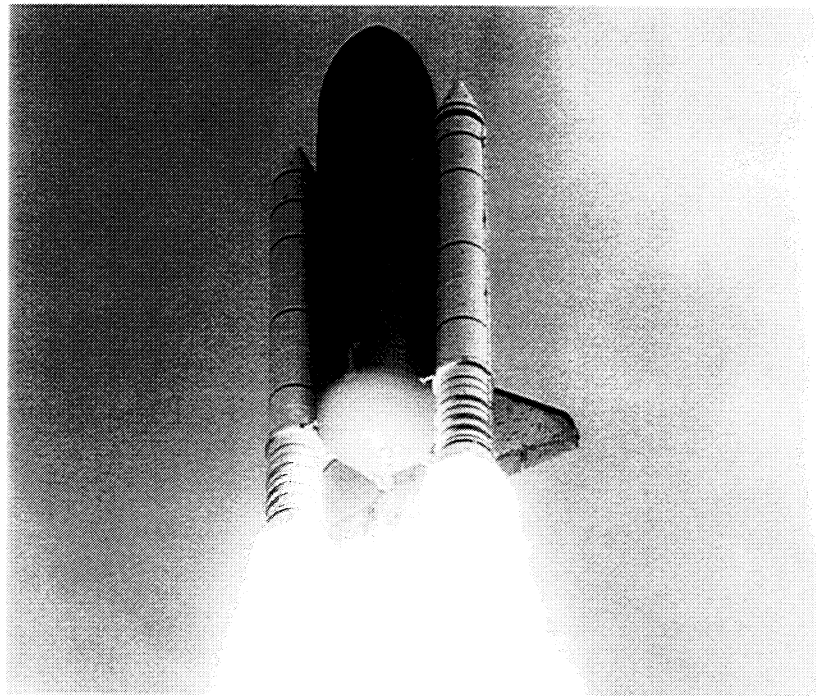
Figure 2.6.3.1 View of ET Intertank after Liftoff

Excellent quality views of the left and right ET intertank thrust panel regions were acquired on the perimeter cameras E54 and E57 at approximately 12 seconds MET. The left and right ET intertank thruster panels were confirmed to be undamaged at approximately 12 seconds MET from these views.

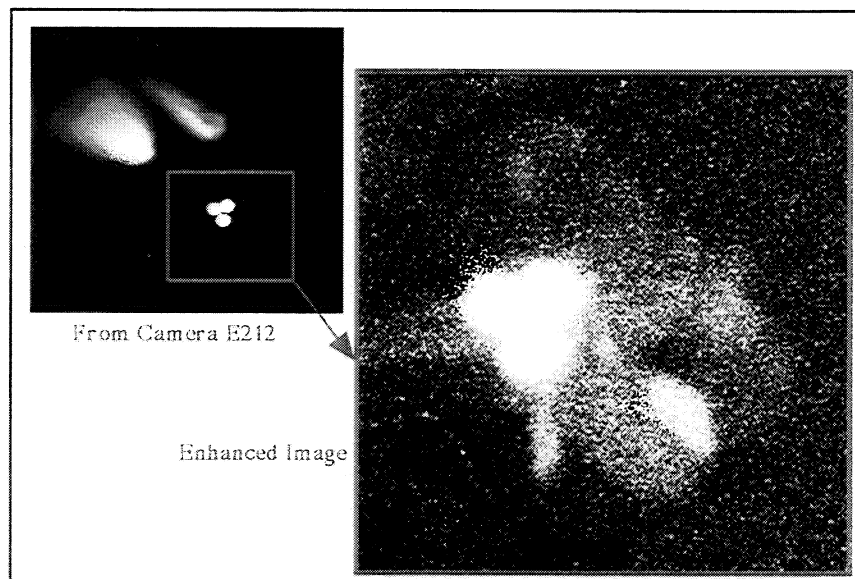
Figure 2.6.3.2 Post SRB Separation View of ET Intertank

The long range tracking camera E212 film imaged the ET intertank region just after SRB separation. However the image resolution was not sufficient to confirm the presence or absence of the intertank thrust panel damage.

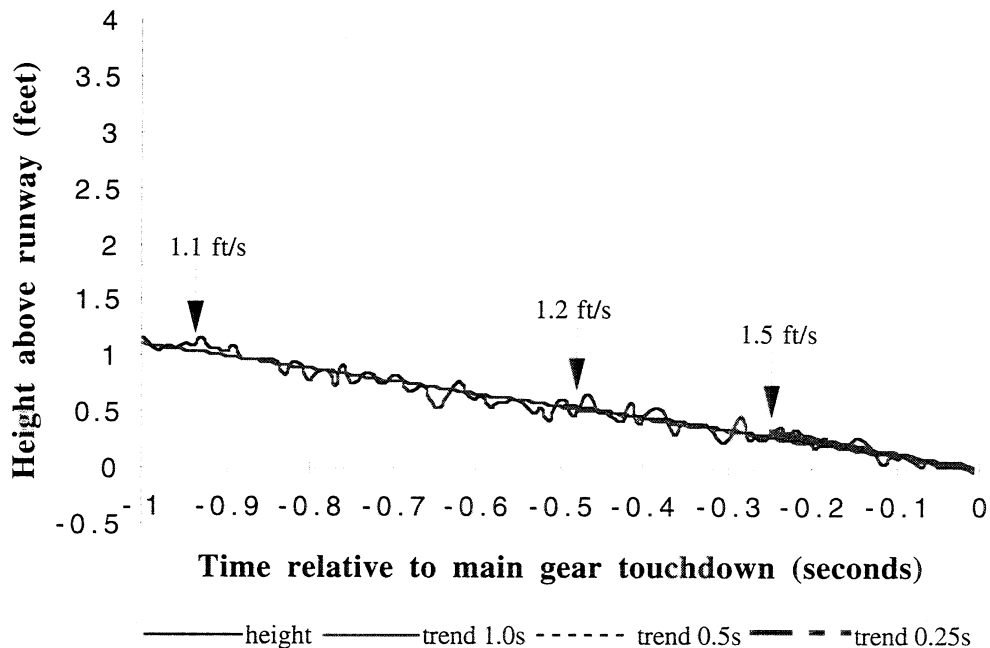
Figure 2.7.1 (A) Main Gear Height versus Time Prior to Touchdown

The measured main gear sink rate values were found to be below the maximum allowable values of 9.6 ft/sec for a 211,000 lb vehicle and 6.0 ft/sec for a 240,000 lb vehicle (the landing weight of the STS-87 Orbiter was reported to be 233,089 lb). The sink rate measurements for STS-87 are given in Table 2.7.1. In Figure 2.7.1(A), and 2.7.1(B), the trend of the measured data points for the image data is illustrated.
